# A Case Report of Titanium Implant with Anatomically Contoured, Partially Submerged Zirconia Abutment and Seven-Year Follow-Up

Neiha Dhanoa and Ajay K. Ojha

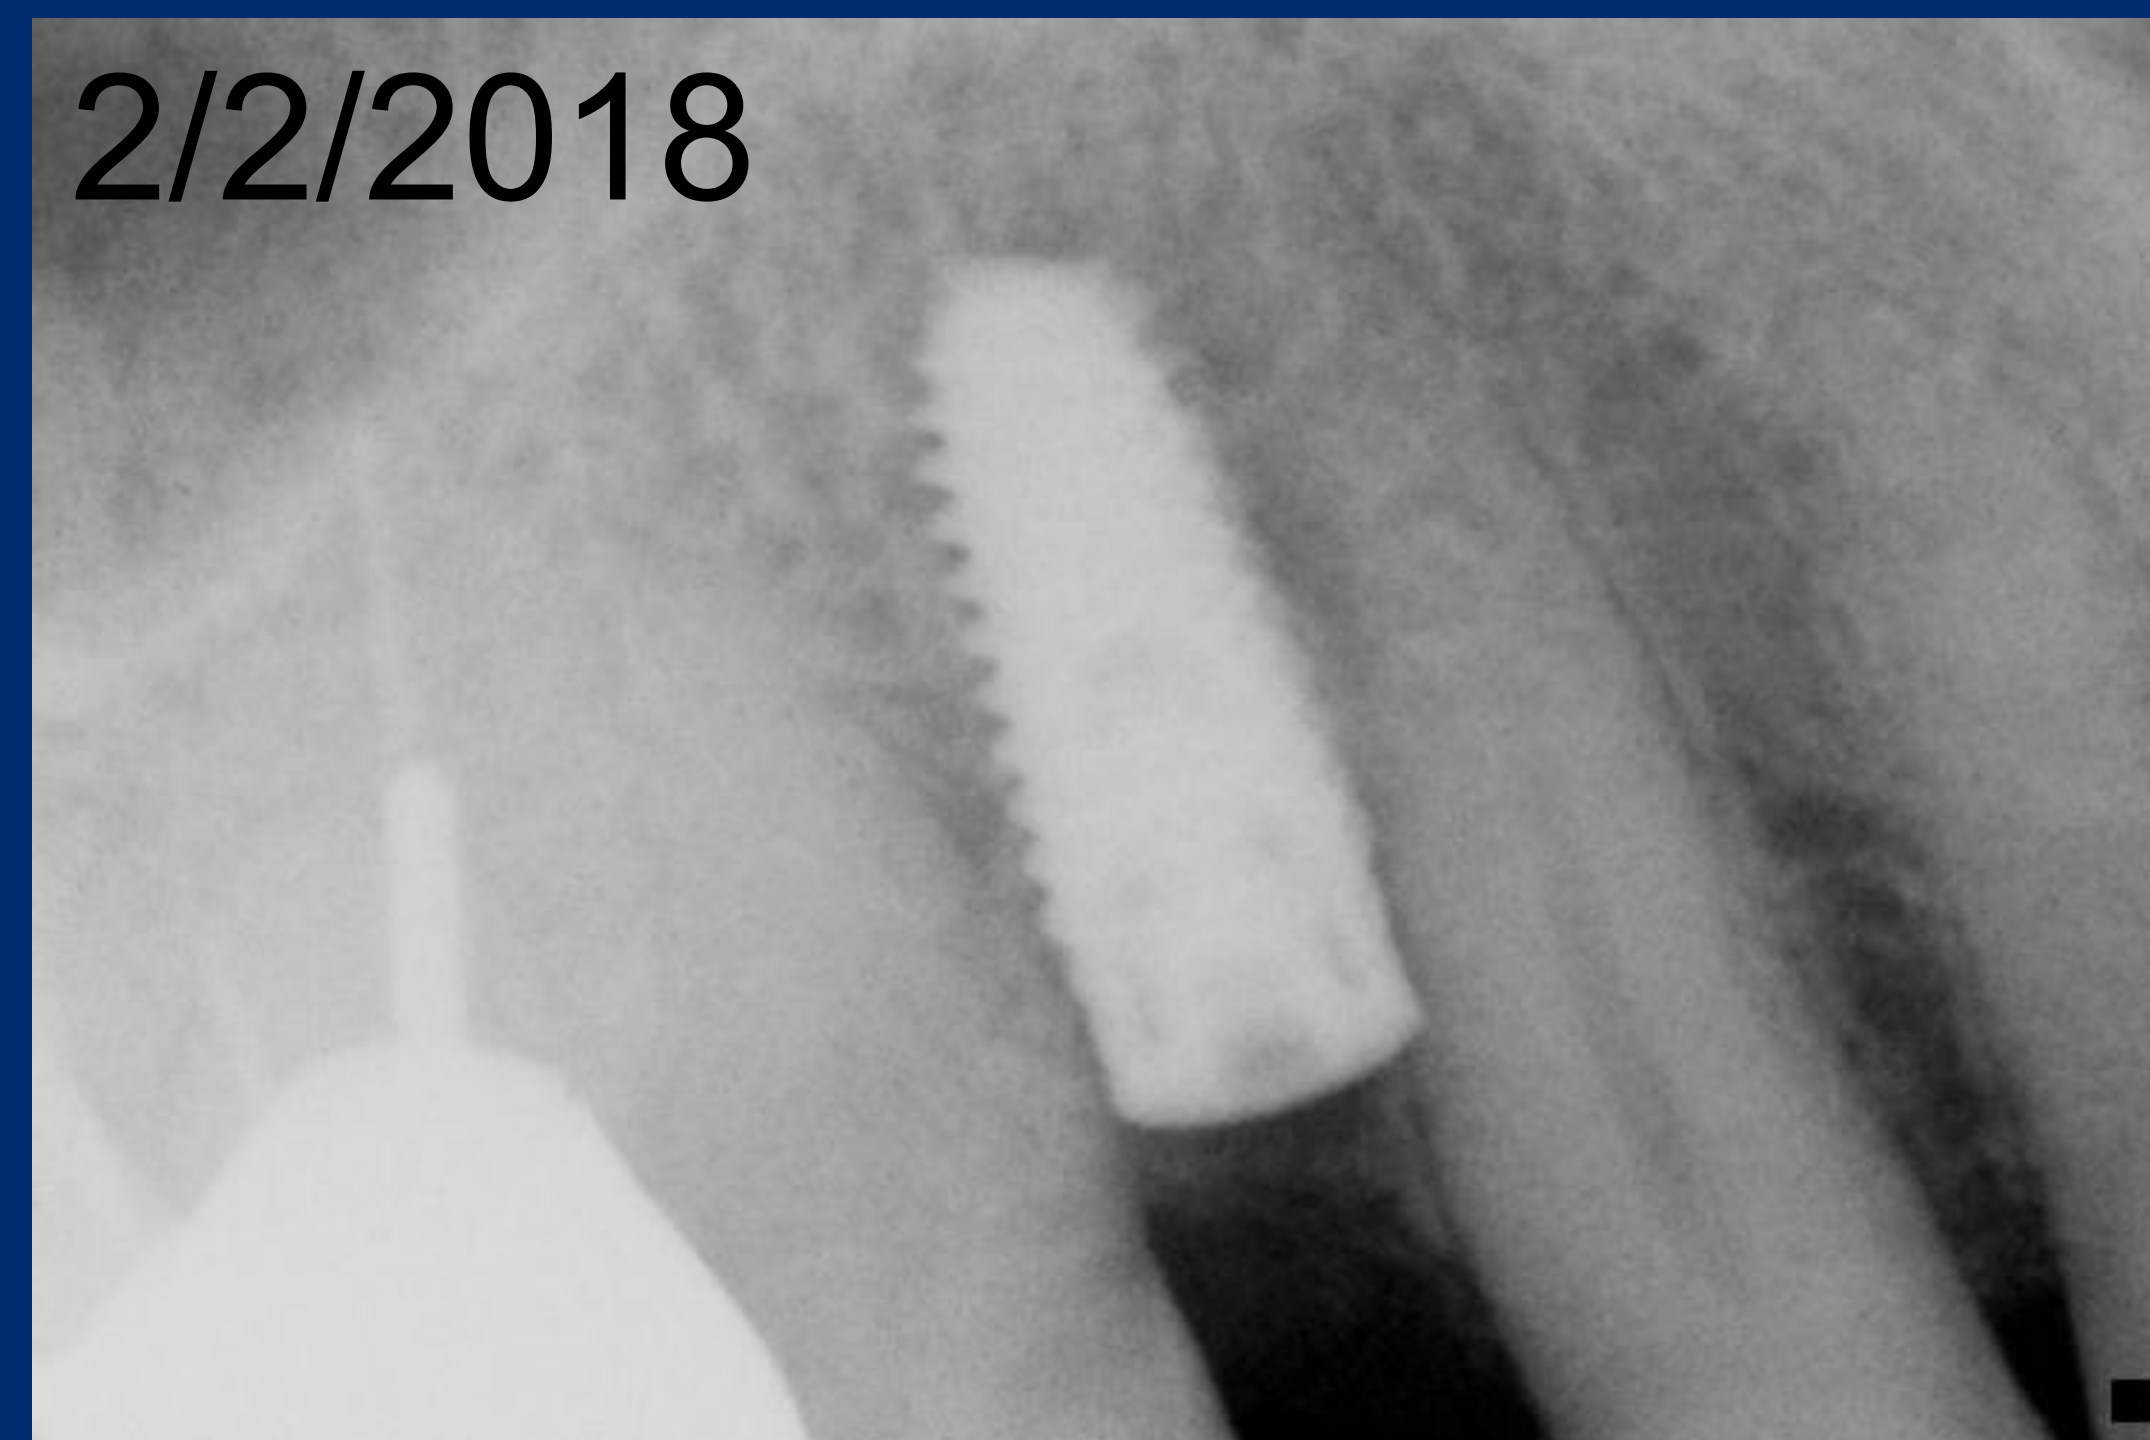
Figure 2: MIS Conical V3 Implant after placement into extraction socket.

A 72-year-old Southeast Asian male presented with a fractured and decayed maxillary right first premolar, deemed non-restorable. The patient was medically stable and provided informed consent for implant therapy. The tooth was extracted atraumatically on **February 2, 2018**, and an **MIS Conical V3 implant (4.3 mm × 11.5 mm)** was immediately placed into the extraction socket. An open-tray impression was made using **polyvinyl siloxane (PVS)**. The site was grafted with **DirectGen freeze-dried bone allograft (FDBA)** and covered with an **RCM-6 resorbable membrane**. The flap was repositioned and sutured with **5-0 PGA sutures**. After a healing period of **five months**, stage 2 surgery was performed on **July 2, 2018**. A **custom zirconia abutment**, fabricated at MIS Dental Laboratory (New Jersey, USA), was torqued to **30 N·cm**. The abutment featured a root-like cross-section resembling the natural maxillary first premolar root form but was delivered with a smooth surface. The subgingival portion of the abutment was manually roughened chairside using **diamond burs and sandblasting** before placement to increase surface texture and potential bone contact.

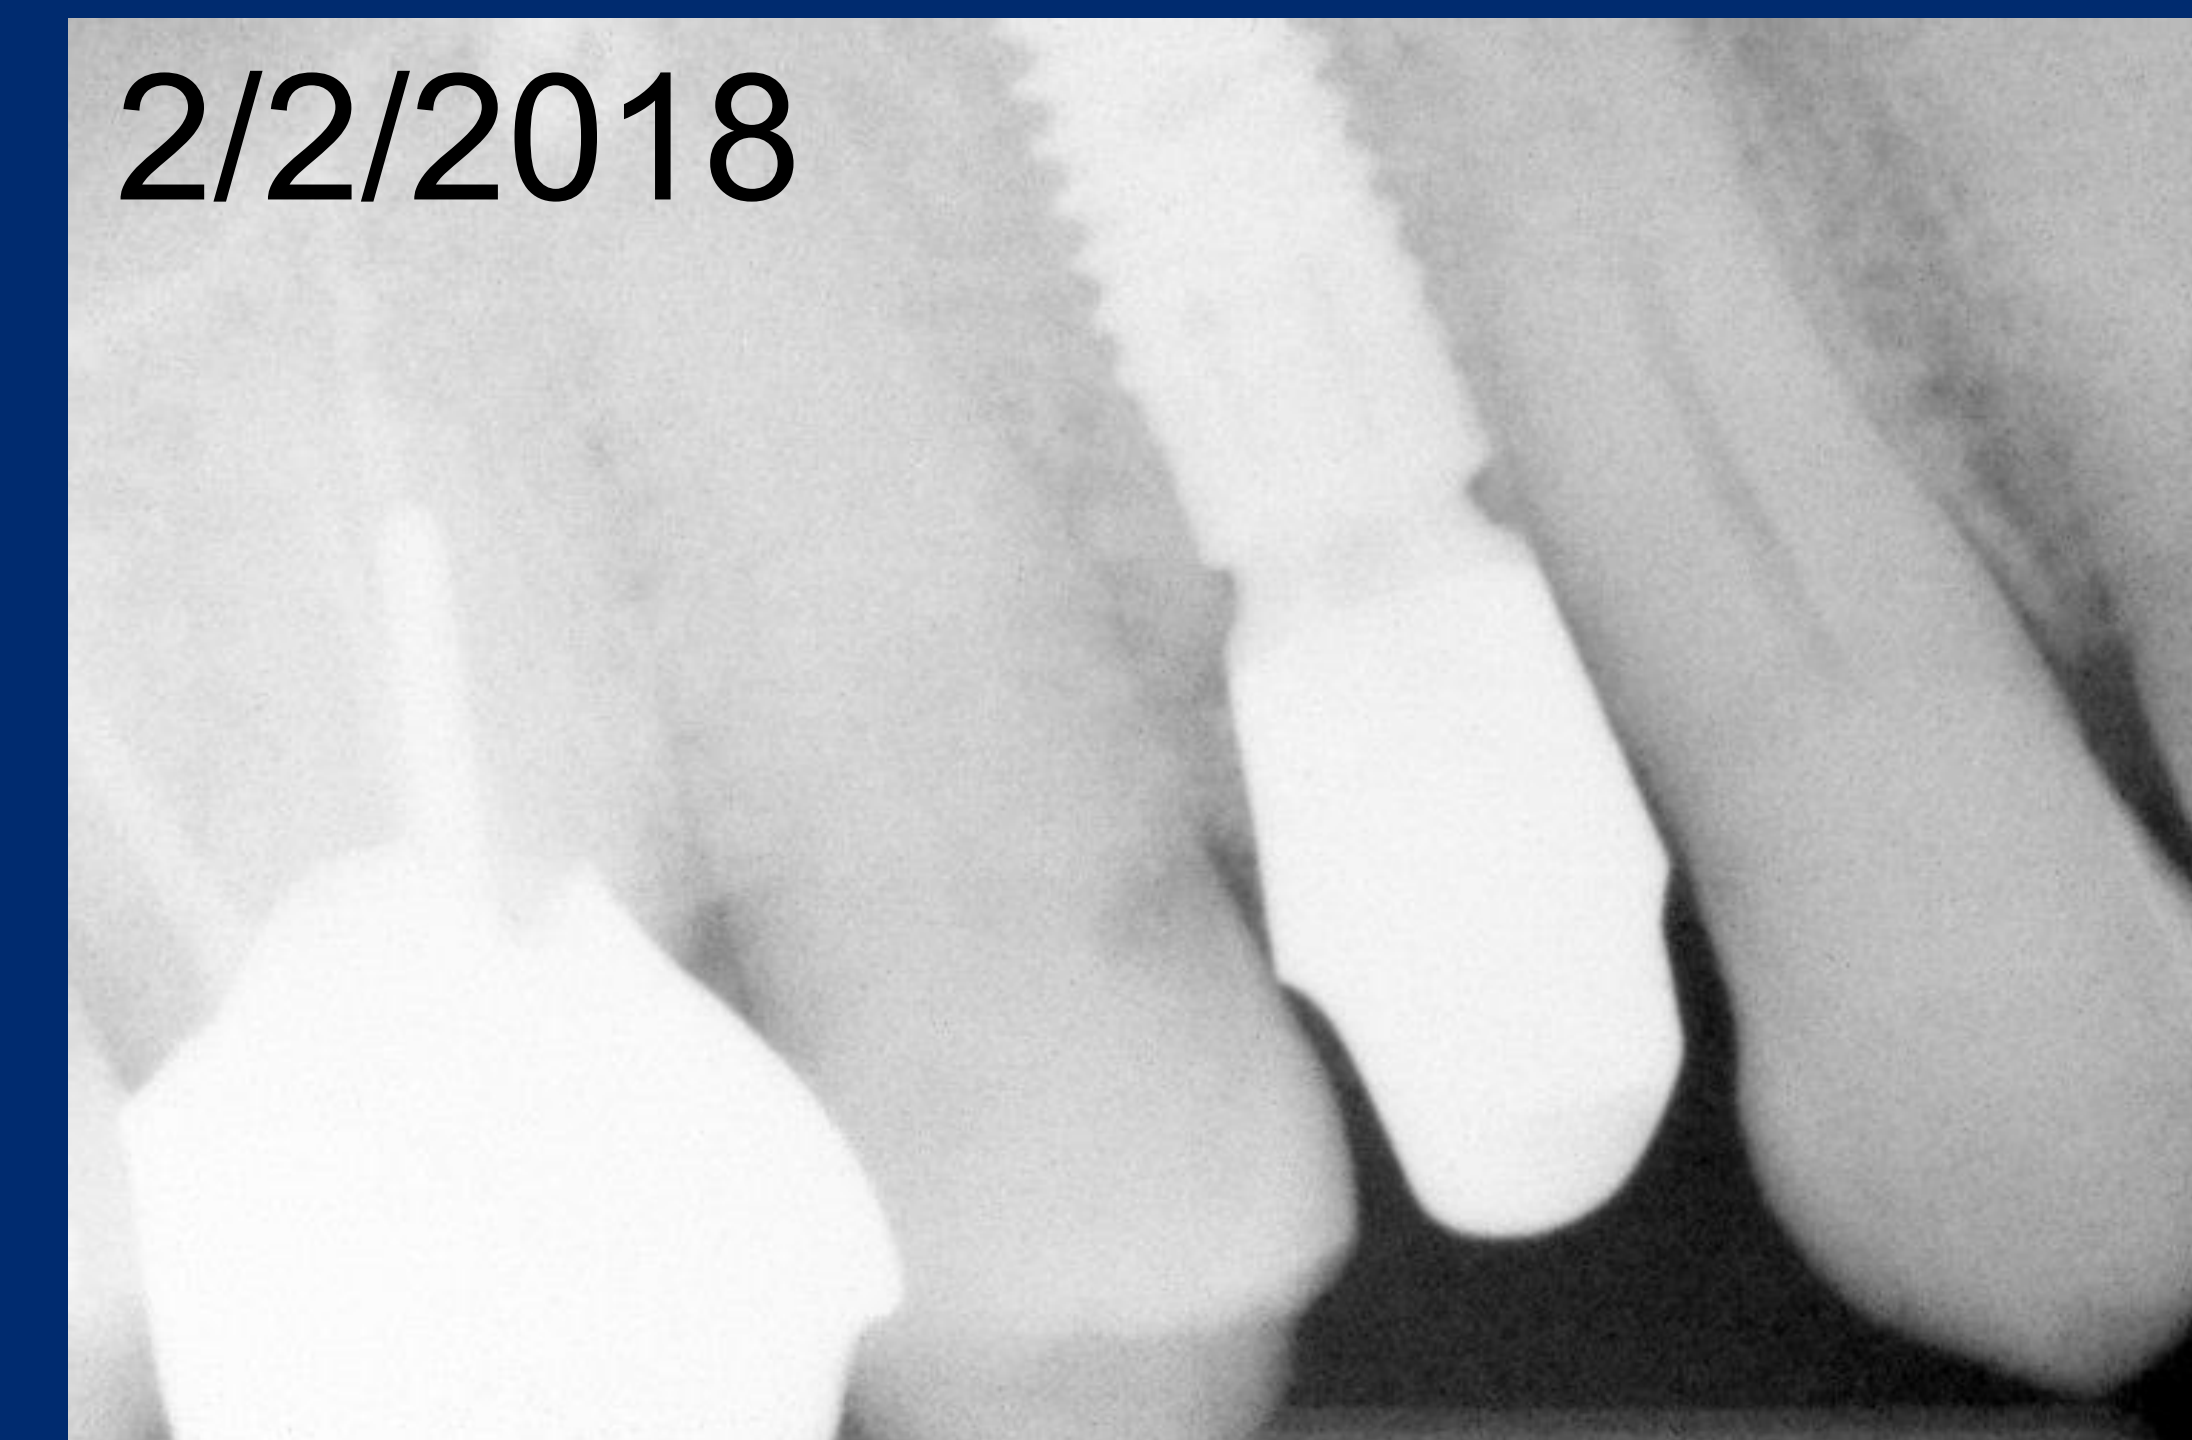
Figure 4: Zirconia abutment torqued in place and grafted around on same day as Stage 2 surgery.

Bone grafting was repeated around the zirconia abutment using the same graft and membrane materials, and the soft tissues were sutured with 5-0 PGA. The abutment was intentionally left uncrowned for six weeks to allow for soft-tissue maturation. After this period, sutures were removed and a provisional PMMA crown was fabricated and cemented with IRM. After serial follow-up visits, a definitive impression was made at the abutment level using PVS material. A zirconia crown was then fabricated and cemented using IRM. The patient was placed on a six-month maintenance schedule, during which peri-implant tissues were assessed clinically and radiographically.

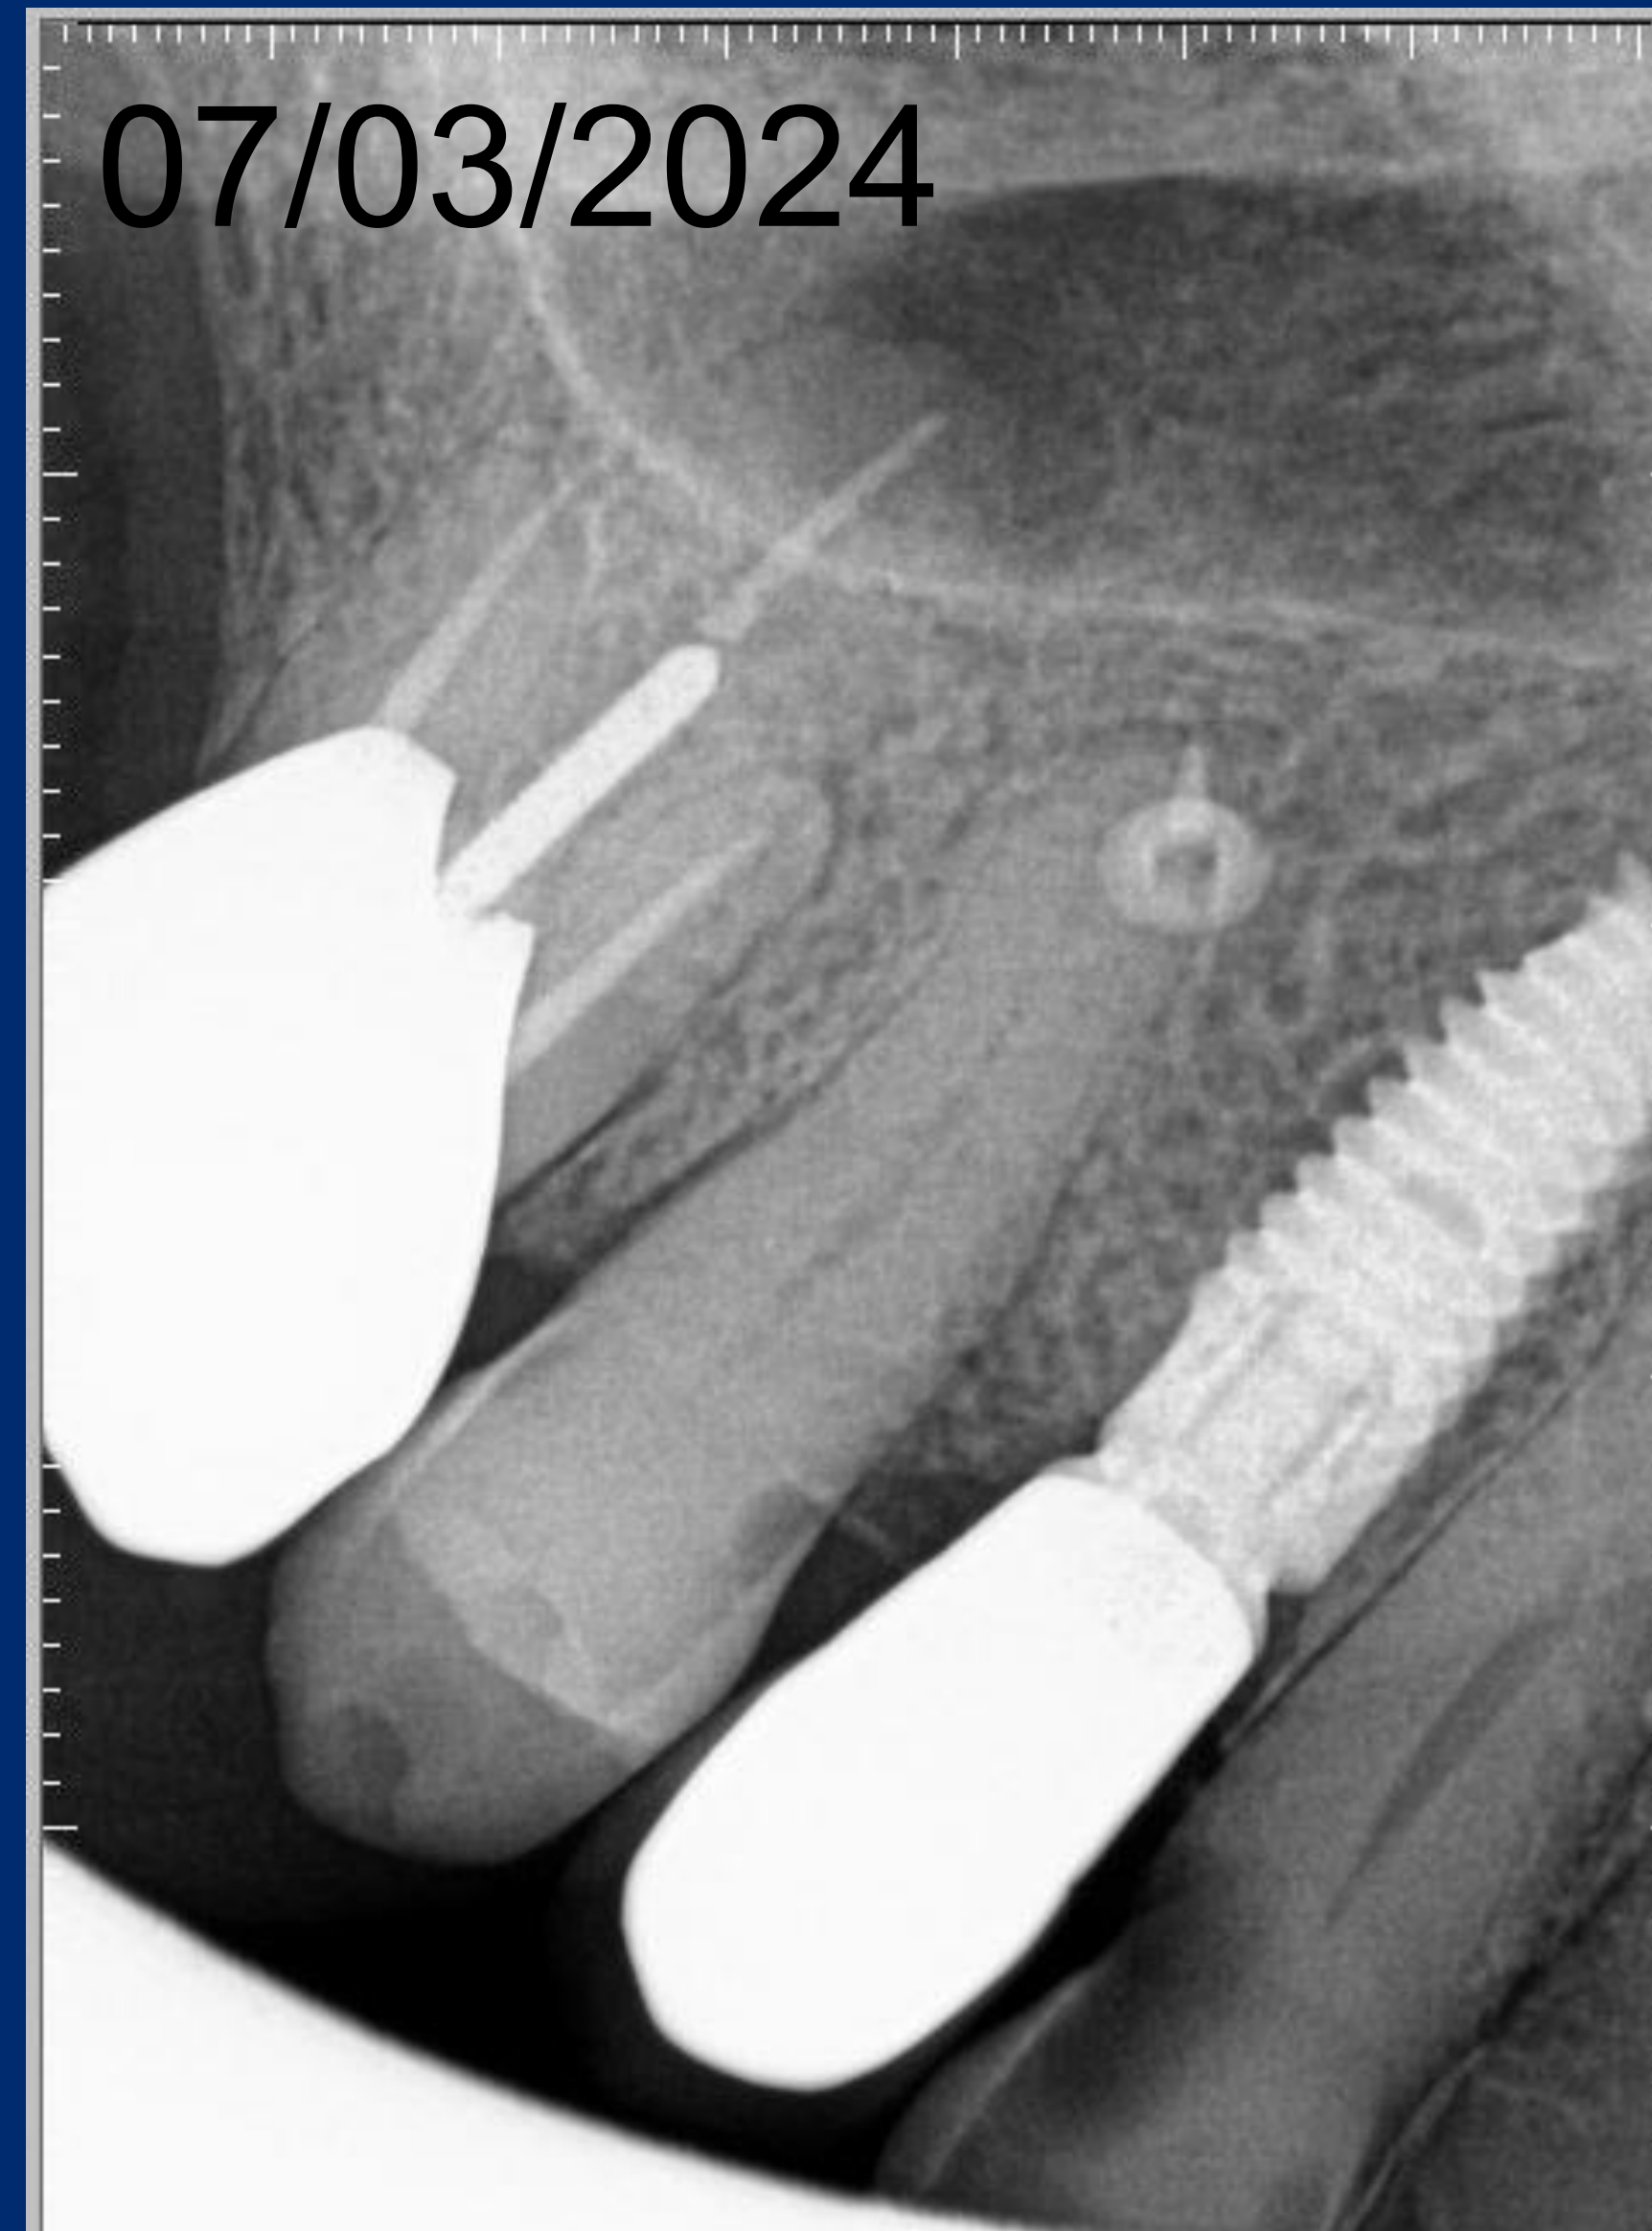
Figure 5: After 6 years bone on distal is still good around the zirconia abutment.

The patient's oral health gradually declined with age, and he presented intermittently with carious lesions on other teeth and generally reduced oral hygiene during subsequent recall visits. However, the implant site remained stable and functional throughout the seven-year follow-up period. Clinical examination revealed healthy peri-implant mucosa without bleeding on probing, mobility, suppuration, or mucosal recession. Radiographically, approximately 2–3 mm of crestal bone remodeling was noted around the zirconia abutment, consistent with physiologic adaptation rather than pathologic loss. The deep implant placement and anatomic abutment design appeared to preserve buccal and palatal bone contours.

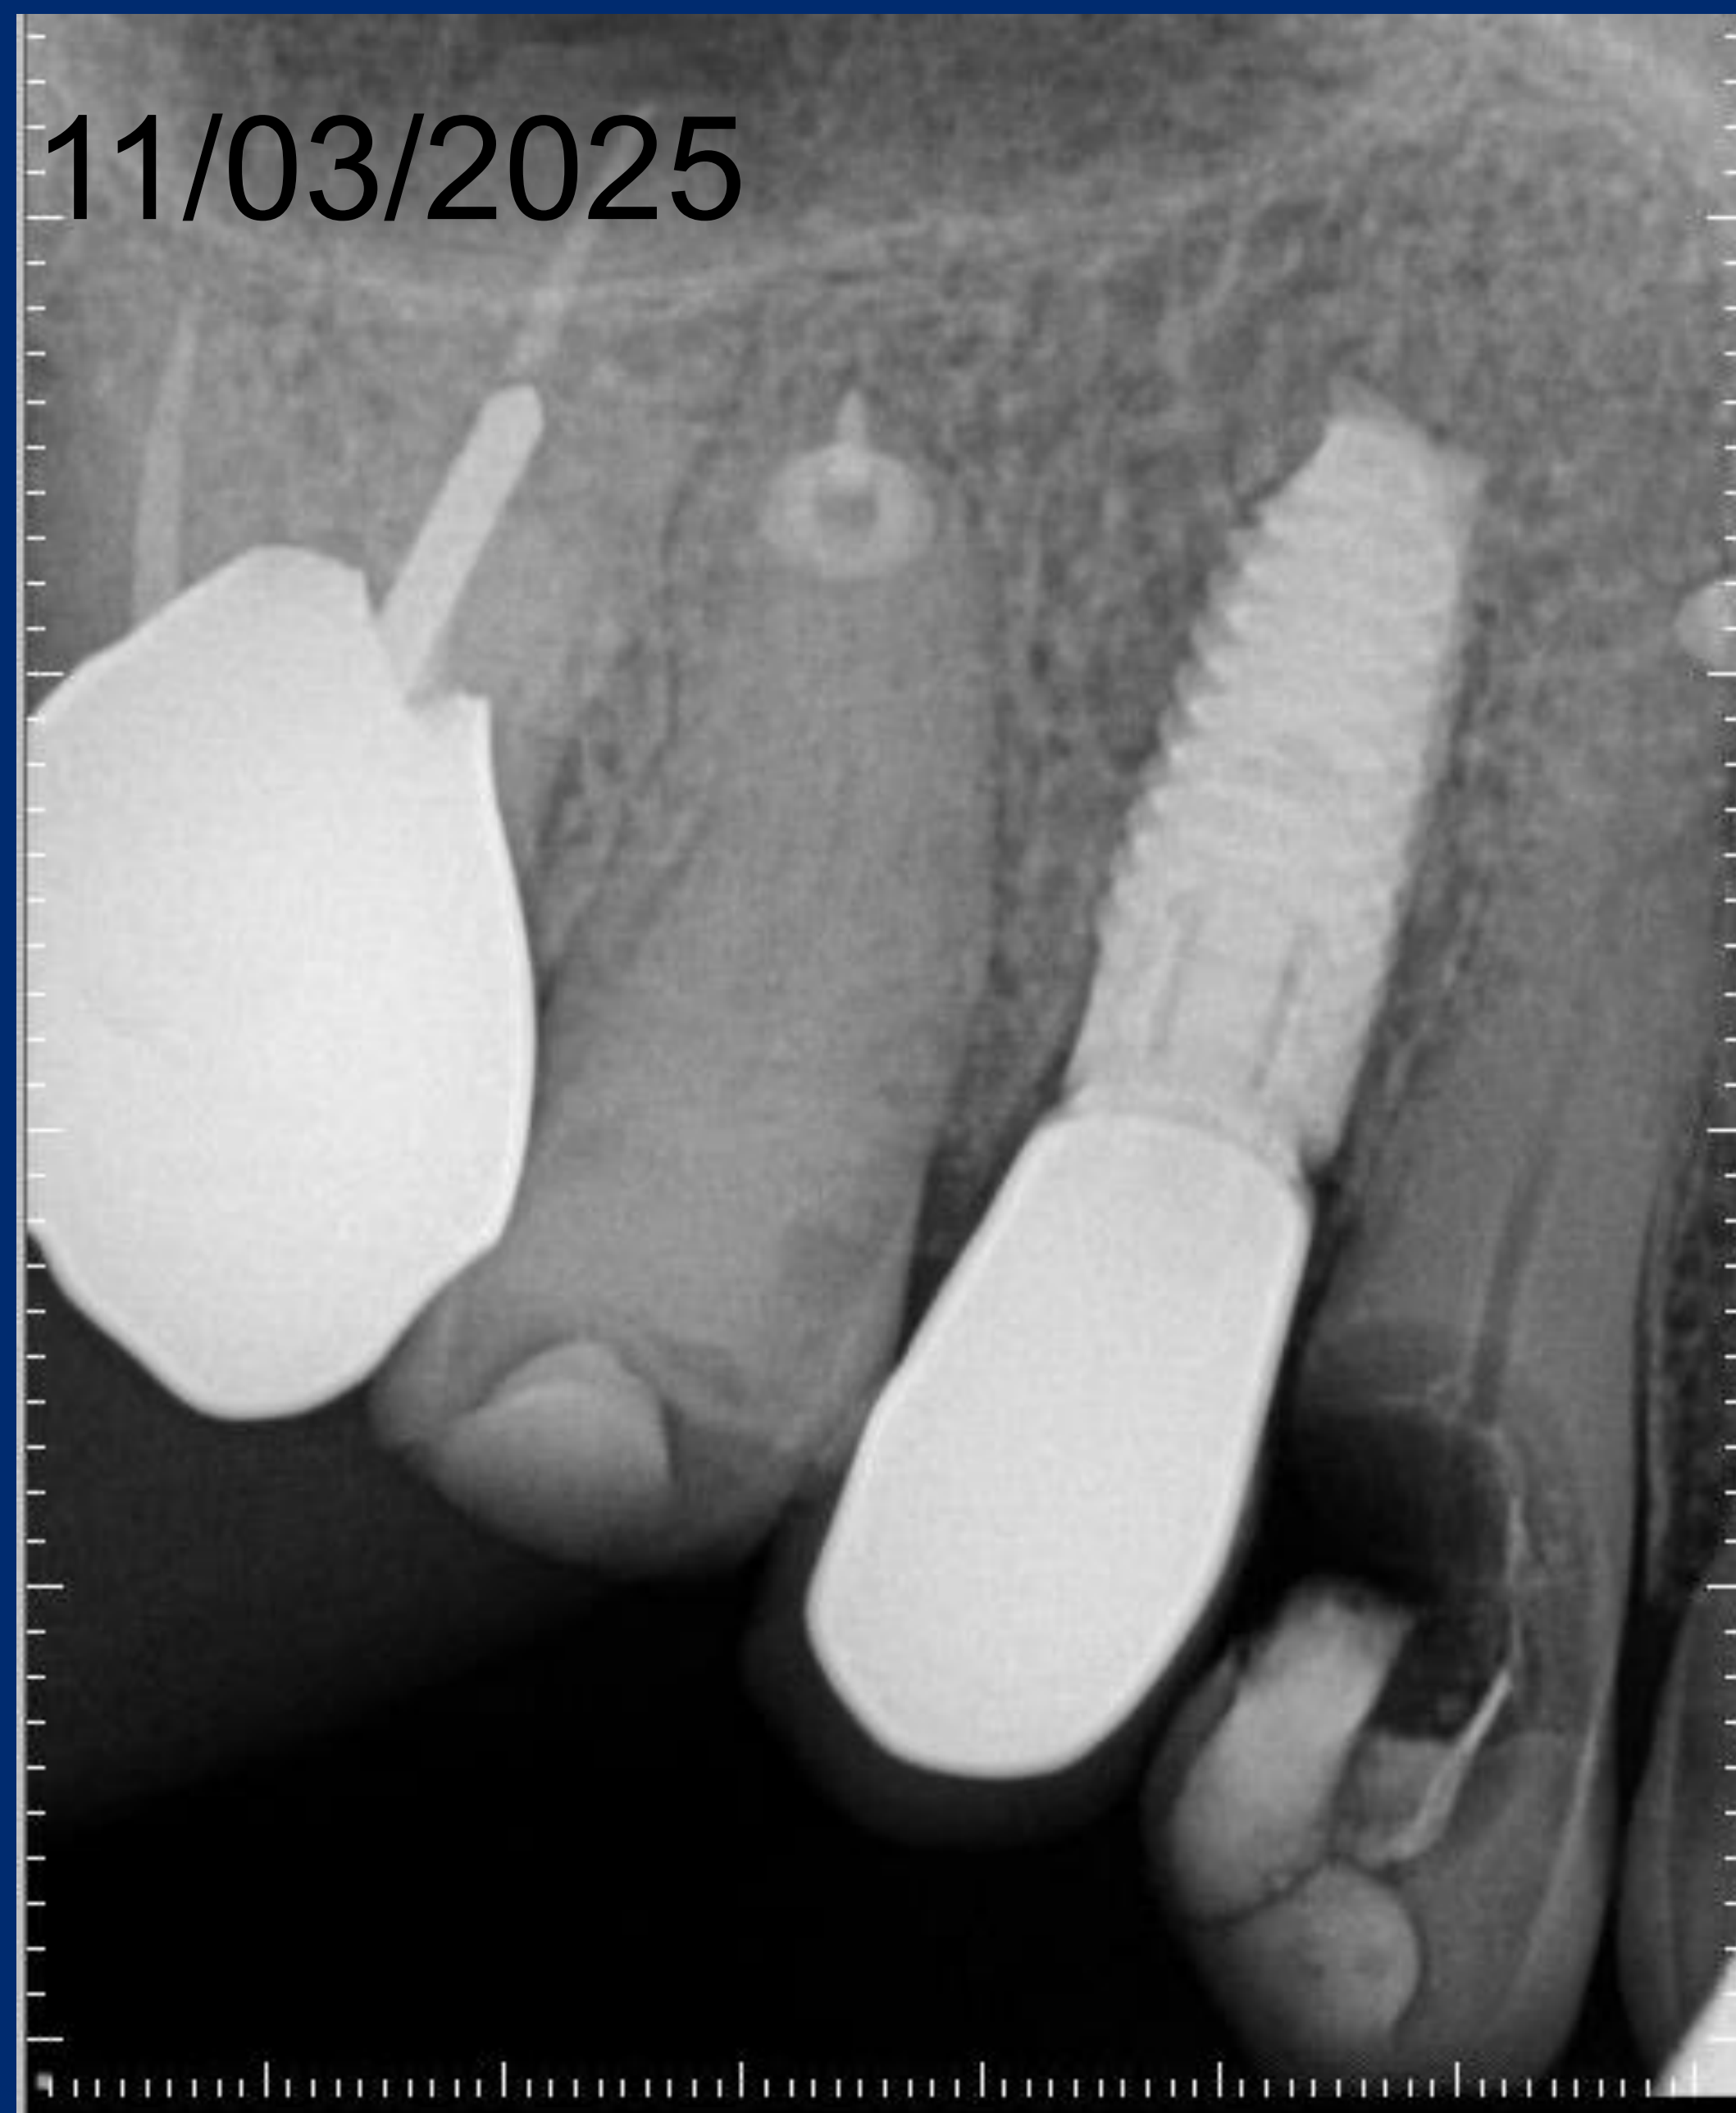
**Figure 6: After 7 years bone on distal is still good around the zirconia abutment.**

This case demonstrates successful long-term function of a titanium implant restored with a custom, anatomically contoured, partially submerged zirconia abutment that appeared to achieve partial osseointegration. Intentional submergence of the implant platform allowed the zirconia abutment to serve as a trans-osteal extension, providing support to peri-implant bone and soft tissue and producing an emergence profile closely resembling that of a natural tooth. Over a seven-year period, minimal bone remodeling and stable peri-implant soft tissues were observed despite declining oral hygiene and deterioration of adjacent teeth, indicating a favorable biological response to the zirconia abutment surface. While histologic confirmation of osseointegration was not obtained, the clinical and radiographic findings suggest that roughened zirconia abutments may allow for direct bone contact and long-term stability in select clinical scenarios. Further controlled studies and histologic evaluations are warranted to validate this restorative approach and to better understand the bone–zirconia interface.
